Major Bus Crashes in Sweden 1997–2007

Kamedo Report No.94

THE NATIONAL BOARD OF HEALTH AND WELFARE

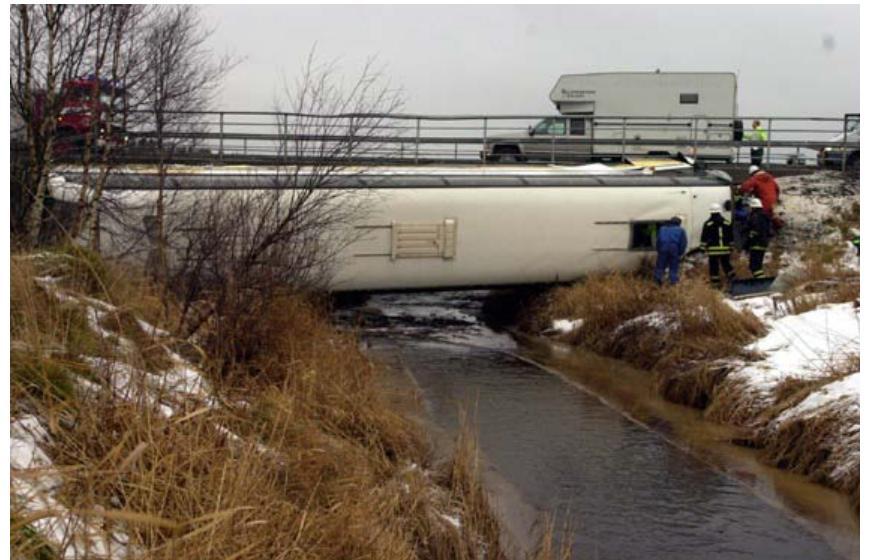
Figure 1. The bus in its final position beside the bridge and across the small river Granån (notice the narrow roof hatches, which are expected to be emergency exits). The front of the bus is to the right in the picture.

The bus that crashed across the small river Granån was a relatively highsided bus buss (3.8 metres) and therefore provided a large surface exposed to the wind. In the prevailing weather conditions, with slush and a relatively strong side wind, the lateral forces were too great, so that the bus was forced off the road "as if by an unseen hand". The Swedish Defence Research Agency (FOI) and the Aeronautical Research Institute have conducted wind tunnel tests with a representative bus model, which strongly indicates that the wind loading initiated the crash. The fact that this is not an isolated occurrence is supported by another study reporting 10 crashes of this kind that have been published by Petzäll et al 2005 [19].

mph) which caused the bus, with its large side surface area exposed, to deviate to the right and over a side barrier. The roadside barrier located before the bridge was too short and weak and was mown down when the bus drove over it. It was therefore of little use in this case. Similar wind conditions and crash mechanisms existed in the crash at Mantorp.

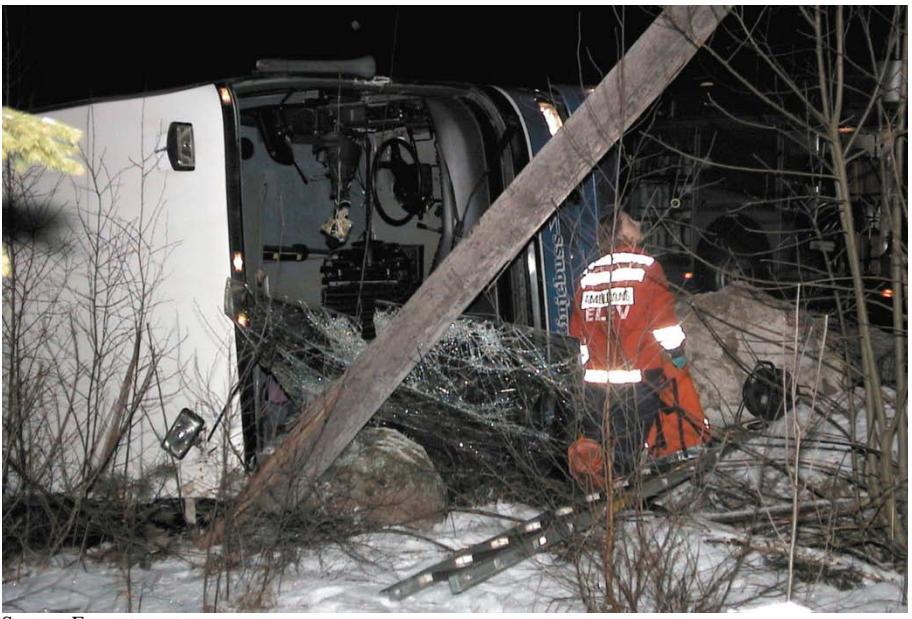
Figure 2. The final position of the bus against an electricity power line post and rock. The power line fell down in the area of the frontal windscreen.

The road and its surroundings have in several cases contributed to exacerbating the subsequent events. In the single crash at Ängelsberg/Fagersta the road surface was very slippery, and the National Board of Accident Investigation found in its crash investigation that the bus, because of the road conditions, could not have negotiated the bend at a speed greater than 25 km/hour. At the time of the crash the bus was travelling at 48 km/hour. What is more, there was no barrier on the outside of the bend to prevent vehicles from going off and down the steep embankment. The bus therefore travelled out across the embankment, rolled 90° before it rapidly and with great force landed at the bottom of the embankment. At least ten people were then thrown out of the bus and were crushed or trapped beneath it.

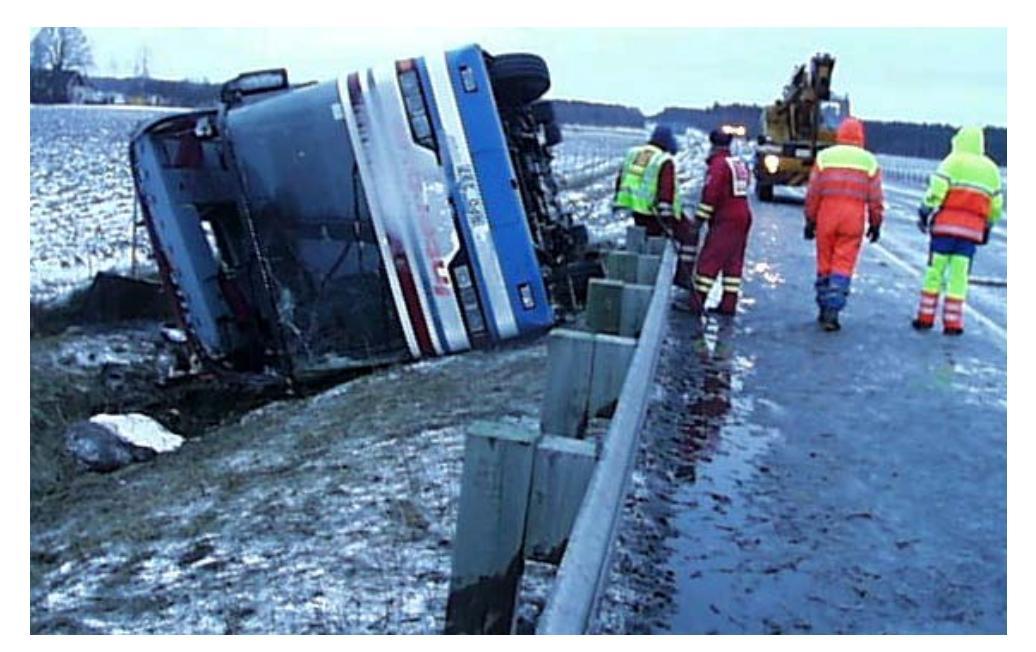
Figure 3. The overturned bus in its final position after having slid on its side for approximately 50 metres.

field straight ahead to the site of the crash. The driver states that he did not feel any effect on the bus from the strong side wind in the forested area, and he estimated his speed to 80–90 km/hour. When the bus came out in the open field area, the driver felt as if the front of the bus was lifted up, which made it impossible to steer. He could not avoid the following crash and everything took no more than a second or two. According to eyewitnesses the speed of the bus was 90–100 km/hour. The bus drifted out towards the right-hand border of the road, went down into the ditch and tipped over onto its right-hand side. At the scene of the crash there was a road barrier on the right-hand side, but the bus left the road before this barrier started and then continued behind the barrier where it came to rest on its side (Figure 3).

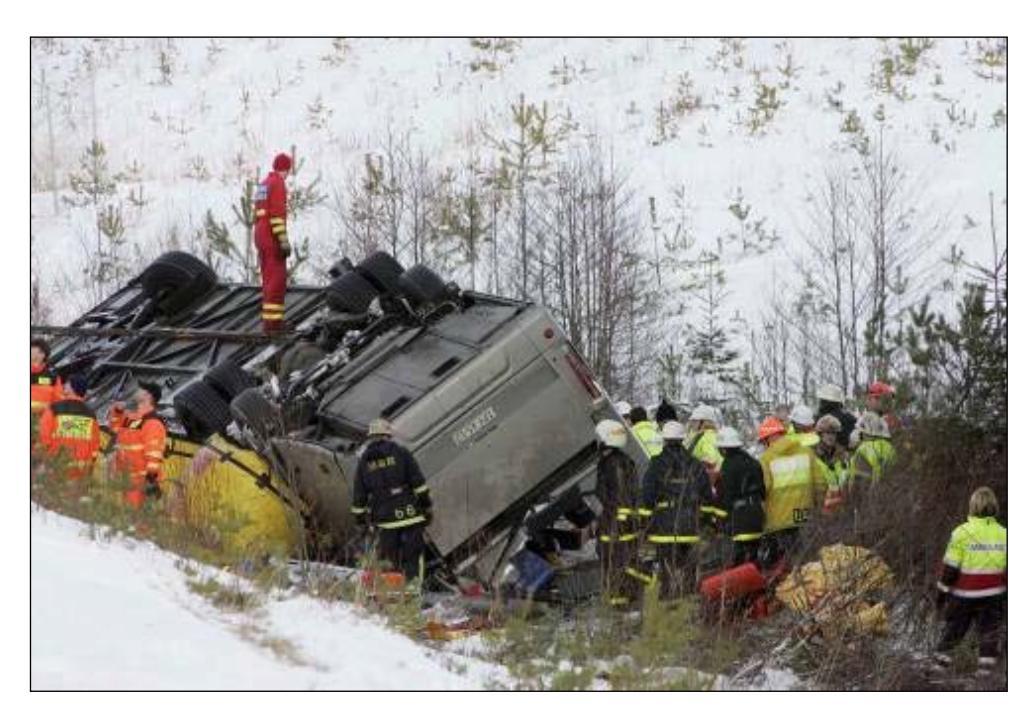
Figure 4. The crash near Arboga was a technical challenge for the rescuers because the bus had ended up on its roof which had been compressed and jammed a number of passengers.

Several of the passengers were trapped, some between the back of the seat and the roof, which meant that all movements of the chassis during the rescue work were potentially dangerous for these passengers and for the ambulance personnel who needed to enter the bus. Source: Swedish Accident Investigation Board

As regards the single crash near Arboga, where the driver fell ill, there was no barrier here either, despite the fact that the relatively recently built motorway should have had a side barrier according to the new standard enforced at the time of the crash. The bus therefore travelled down a long embankment where a few decimetres rock caused the bus to overturn and land on its roof. At the bottom there was a tree stump which stopped the bus's forward motion and broke the roof backwards. The roof was thus deformed backwards and to the side, so that those sitting on the right-hand side in the bus were exposed to further impact directly from the ground that they were traversing.

The bus crash near Arboga, illustrated in a dramatic way the difficulties encountered in the rescue work when the bus ended up upside down. In the crash all of the windows in the bus shattered at the same time as the window pillars gave way and were broken down. The roof was pressed down and displaced backwards and to the left, so the people in the far right row of seats were subjected to direct force against their heads from the ground. In this case none of the passengers were thrown out, despite the fact that all of the windows were crushed. Possibly the fact that around half of the passengers were using their seat belts contributed to this [6].

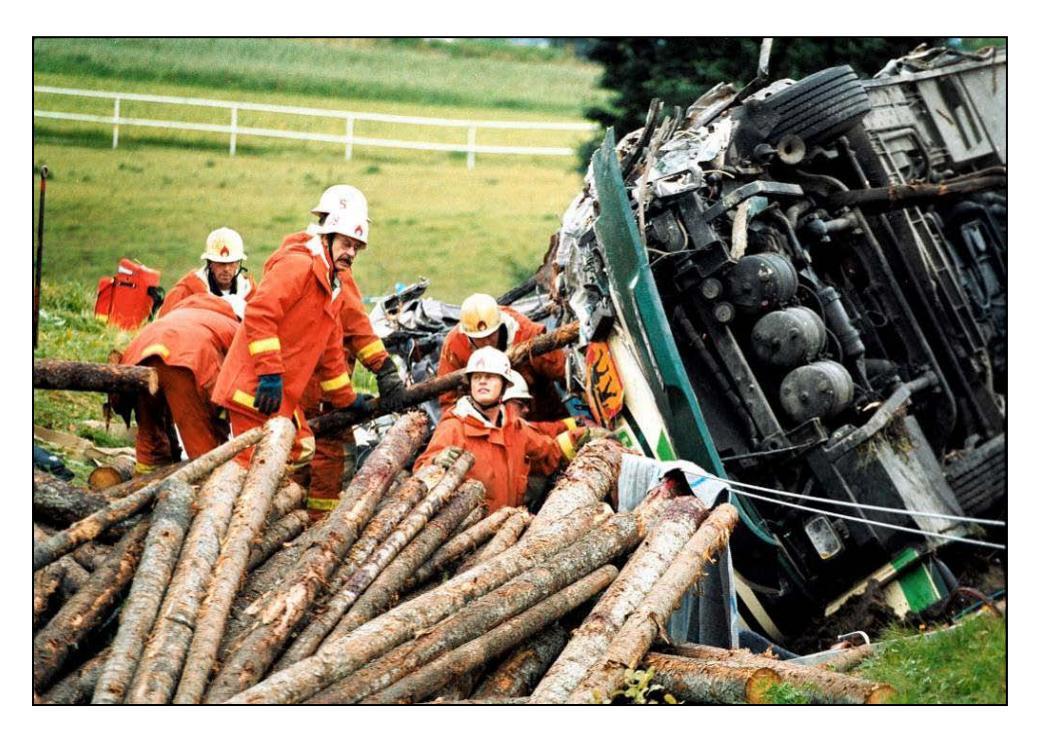
Figure 5. The collision between a school bus and timber truck at Indal.

In the collision, the front left-hand side of the bus was filled with the penetrating logs which caused many of the fatal injuries. This bus also finally ended up with its right-hand side downwards, and the doors blocked.

A bus carrying 41 occupants, primarily schoolchildren, collided head-on with a articulated timber truck in September 2001 at Indal, 30 km northwest of Sundsvall [13,14]. The left-hand front tyre on the truck suddenly exploded just before meeting the school bus. The truck then crossed over into the bus's lane. The bus driver attempted to avoid a collision by moving to the right-hand side of the road but nevertheless did not succeed in avoiding a collision. The left front side of the truck hit the left front side of the bus. Timber broke free from the truck and continued into the bus. After the collision the bus was lying on its right-hand side in the ditch, whilst the truck continued over onto its right-hand side where it descended into a small ravine and rolled, ending up upside down.

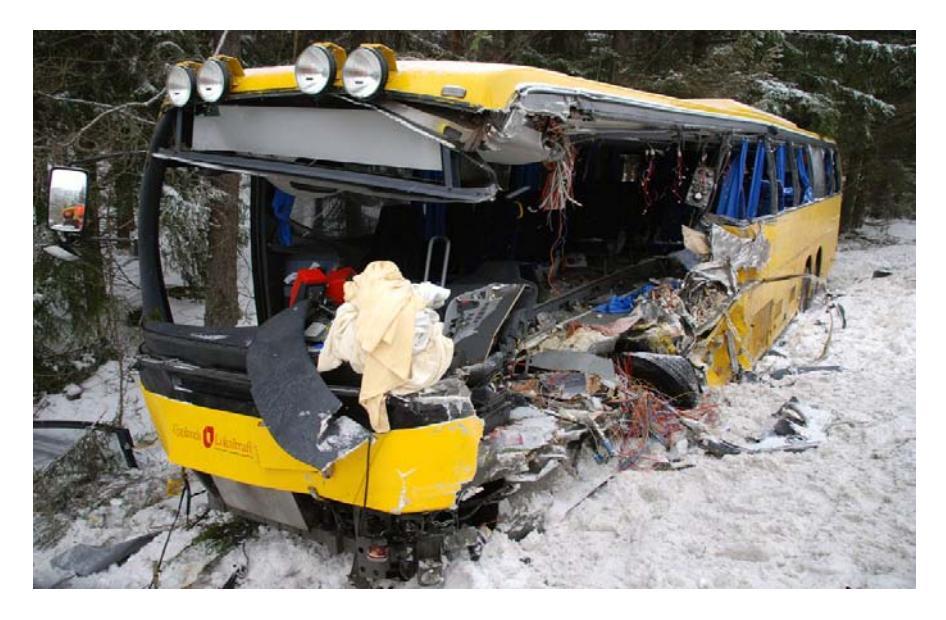
Figure 6. Both buses were subject to similar deformation damage after a "small overlap" collision. In this bus five people died.

The 5+1 people who died were all sitting in the area where one bus forced its way into the other and were therefore subject mainly to "penetrating force". Source: Ulf Björnstig.

Two identical buses collided with each other an early morning in February 2007 on the narrow and busy 7-metre road between Östhammar/Öregrund and Uppsala. A total of 62 occupants were travelling on the buses, of whom many were commuting to their work [15]. There had been a light snowfall during the night and the road conditions were wintry, with slush and patches of ice. The road had been ploughed on one side in the direction Östhammar-Uppsala. The buses came from opposite directions on a long straight stretch with forest on both sides. Just before the collision, one bus passed a large high truck with trailer which was standing close to the road but in a parking space. Witness accounts of the sequence of events vary, and objective details are so few that the Swedish Accident Investigation Board has not succeeded completely in elucidating the final seconds before the crash. The buses crashed with a small overlap of their left-hand sides, which were substantially demolished. The side wall of one bus entered just inside that of the other bus until their front wheels met each other and were turned out 90 degrees. Both buses then passed each other and stopped in the ditch.

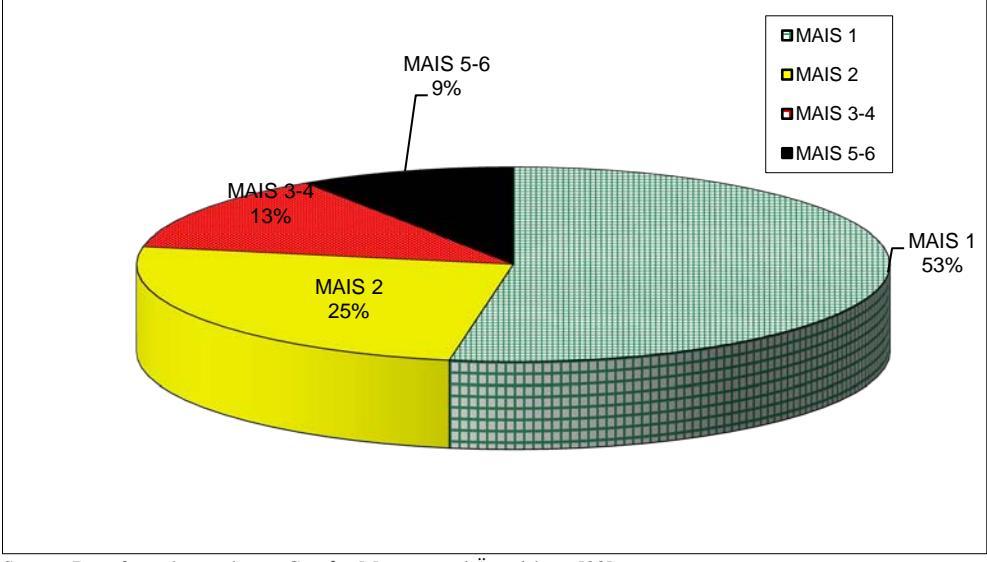
Figure 8. The proportion of injured from the crashes at river Granån, Mantorp, Råneå, Ängelsberg, Arboga and Rasbo distributed according to the degree of severity of their injuries (total of 258 casualties)

Below we provide a view of the injuries of the 258 casualties involved in six crashes for which detailed injury information was available: the river Granån, Mantorp, Råneå, Ängelsberg, Arboga and Rasbo crashes (Figure 8). Approximately half of the casualties suffered moderate or more serious injuries (MAIS 2+), that is from moderate injuries (fractures, concussion with loss of consciousness) up to maximal injuries (MAIS 6). More than one in five had injuries classed as MAIS 3+. (MAIS 3 roughly corresponds to injuries requiring intensive care). Almost one in ten had critical or maximal injuries (MAIS 5-6), mostly fatal. A majority died at the scene, but for example at the Arboga crash one hypothermic (32° C) casualty (MAIS 4) died later in hospital. Several of those who died in the Arboga crash suffered no real fatal injuries, but died because of immobilisation of thorax when they were stuck between the crushed roof and the interior of the bus. It has been assessed that at least four of those stuck people lived for a half to one hour after the crash – i.e. they would have been potentially rescuable.

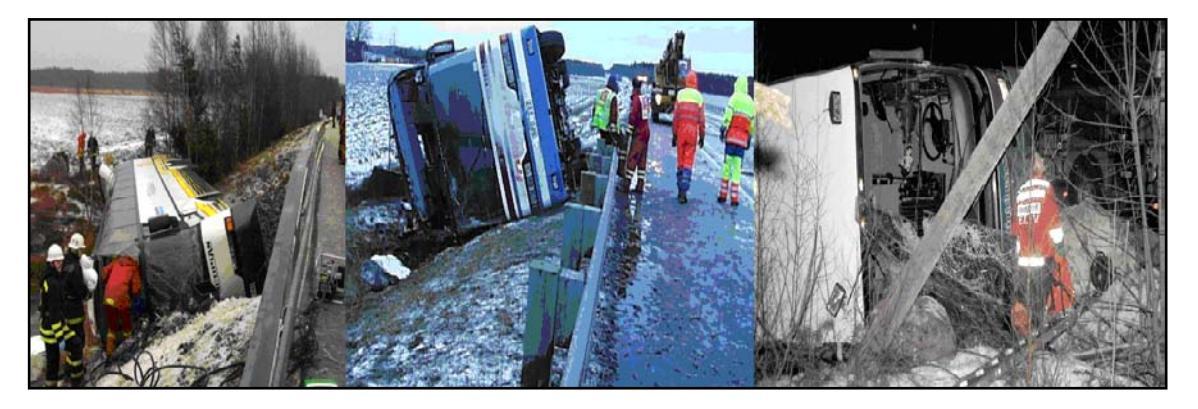
Figure 9. Examples of the crashes at small river Granån 2001, Mantorp 2002 and Ängelsberg 2003, when the bus in each case rolled 90° to the right

It has been shown that in both single crashes and collisions the bus often ends up at the side of the road with the right hand side downwards, so that the doors are blocked. The single crashes at small river Granån, Mantorp and Ängelsberg, are some examples of this course of events, and all these crashes have similarities in the kinematics (Figure 9).

This means that the passengers were injured in several different phases of the crash; (i) when the bus rotated to the right and (ii) when the rotation suddenly stops when hitting the ground. Some unbelted passengers were thrown out of the bus, when the side windows were crushed. Other unbelted passengers may have contributed to push passengers out on the "downward side". In certain cases the bus continued to slide on the ground a number of metres before it stopped, and then the ejected passengers suffered further injuries of course. One example of this is the crash in Ängelsberg, where 10 people, either entirely or partially, ended up beneath the bus, after having been ejected through the crushed side windows [5,21]. Unbelted passengers were also injured when they were thrown against seatbacks, armrests or other passengers. In those cases where the bus rolled 90 °, the unbelted passengers were also found piled up against the lowest side.

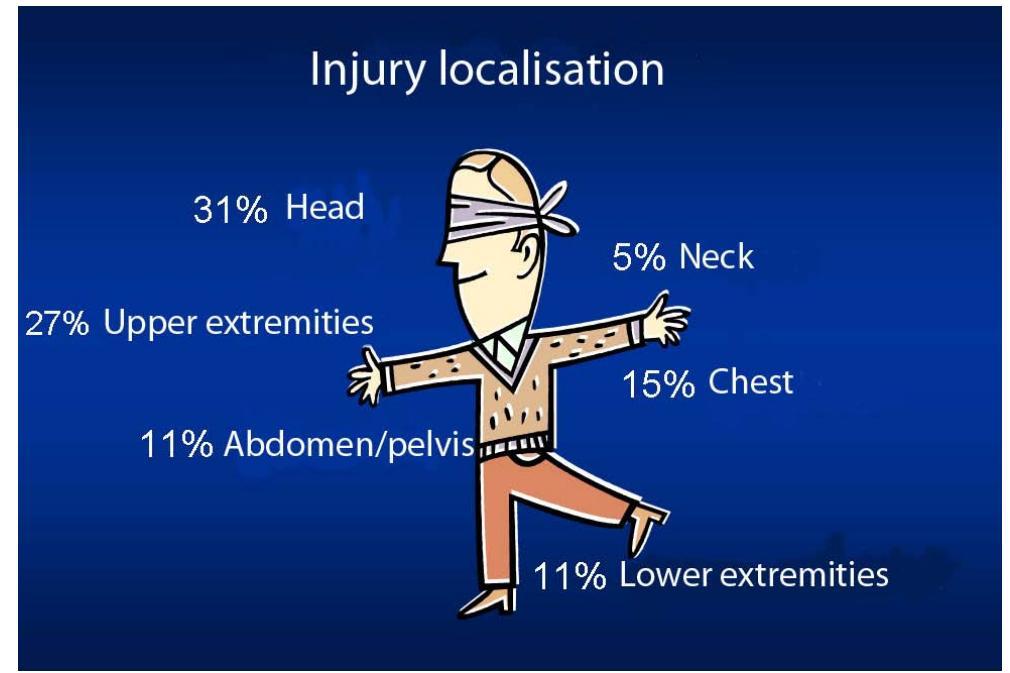
Figure 10. Distribution of 277 injuries among 128 injured persons from the three single crashes described with 90 degree rollover to the right

On average, the casualties had two injuries each. A good third had received cuts from glass. The localisation of the injuries is shown in Figure 10. Head injuries comprised a third of all injuries, and approximately 60% of those people with head injuries had an intracranial injury, often concussion, but more serious inter-cranial bleeding were also observed. Serious skull injuries are often associated with neck injuries, but despite this, moderate or serious (MAIS 2+) neck injuries were rare in this material (fewer than 2% of those injured). Of the injuries to the thorax, half were rib fractures. A few were fractures to one or more vertebrae in the chest or lumbar regions. Extremity injuries were most common in the upper extremities, of which one in four involved a fracture, amputation or crush injury. The fatal injuries affected primarily the thorax and head [22].

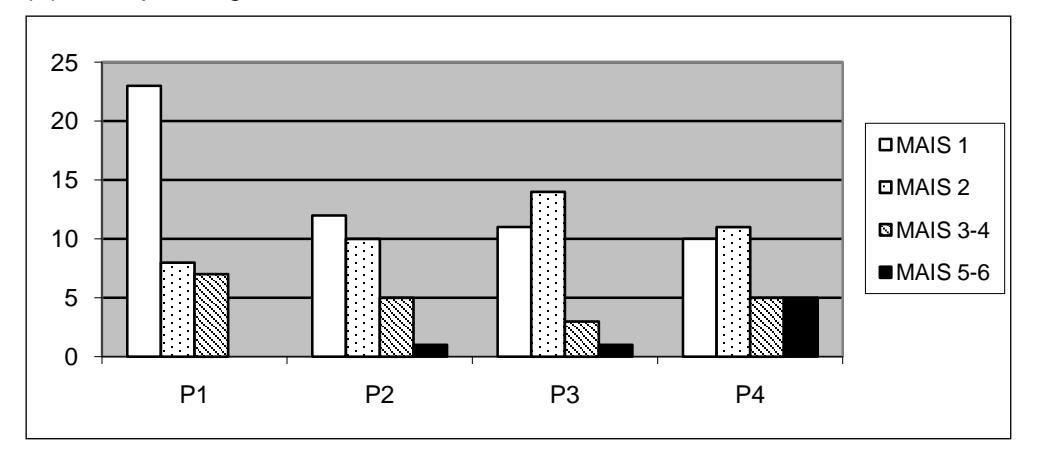
Figure 11. Distribution of injured passengers and their injury severity (MAIS) from the crashes at the small river Granån, Mantorp and Ängelsberg by the row position (P) of the passengers.

P1 is the row of seats furthest to the left and P4 the row furthest to the right. Source: Data from the crashes at small river Granån, Mantorp and Ängelsberg [22]

The seats in a bus are usually placed in four longitudinal rows which can be numbered from left to right. P1 is the row furthest to the left in the direction of travel; P2 is the one next to it; P3 is the row on the other side of the aisle and P4 is the row furthest to the right. According to Figure 11 below, it was the passengers in position P4 who primarily suffered serious or more severe (MAIS 3+) injuries, when the bus rolled 90° to the right. These passengers were thus sitting on the side which hit the ground, and were therefore subjected to the highest forces and had also a risk of being ejected and trapped beneath the bus.

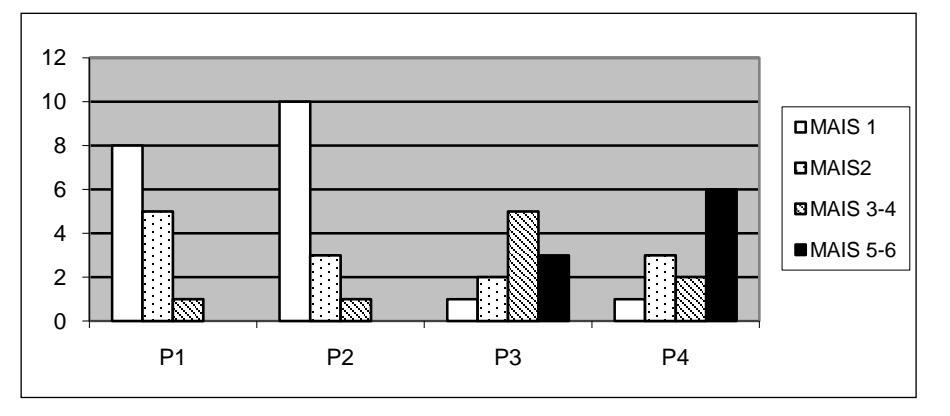
Figure 12. The number of injured by injury severity (MAIS) and seating position (P) in the Arboga crash in 2006 [6]

When the roof of the bus collapses, the space between the seats and the roof, or hat rack, is substantially reduced. According to the rescuers who worked at the bus crash in Arboga, the headrests were in contact with the roof at the back of the bus, thus providing only a limited survival space. When the roof was pressed down, the window pillars were bent downwards and inwards across the seats. Many of the unbelted passengers were crushed between the seats, the roof and other fittings. [15]. When the roof was then also displaced to the side, exposing the passengers in the right-hand side row for direct contact with the ground, their chances of survival fell dramatically. All of those who died, and most of those with serious or severe injuries (MAIS 3–4), sat in the right-hand rows (seats P3 and P4), where the passengers were most exposed. Of the 51 casualties 34 (67%) received moderate or more serious injuries (MAIS 2+), which makes the Arboga crash to the crash with the highest proportion of non minor injuries.

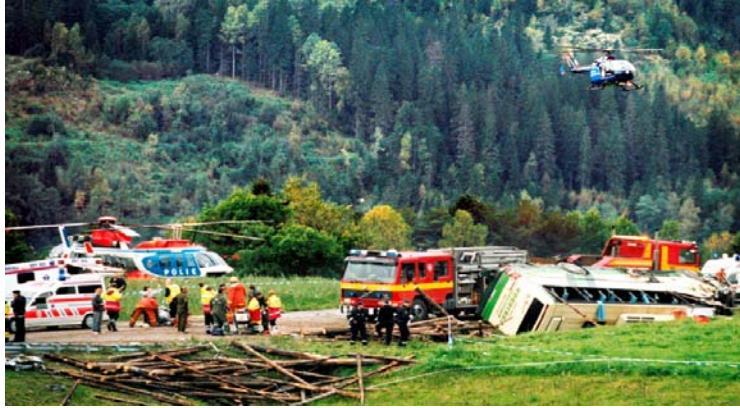
Figure 13. The crash at Indal in which a timber truck collided head-on with a bus carrying schoolchildren.

At the collision at Indal 42 people were injured, of whom six died. The most serious injuries were caused by timber which penetrated the bus. The truck driver, who also died, was trapped hanging upside down for a relatively long time. This may have contributed to aggravating the consequences of his injuries.

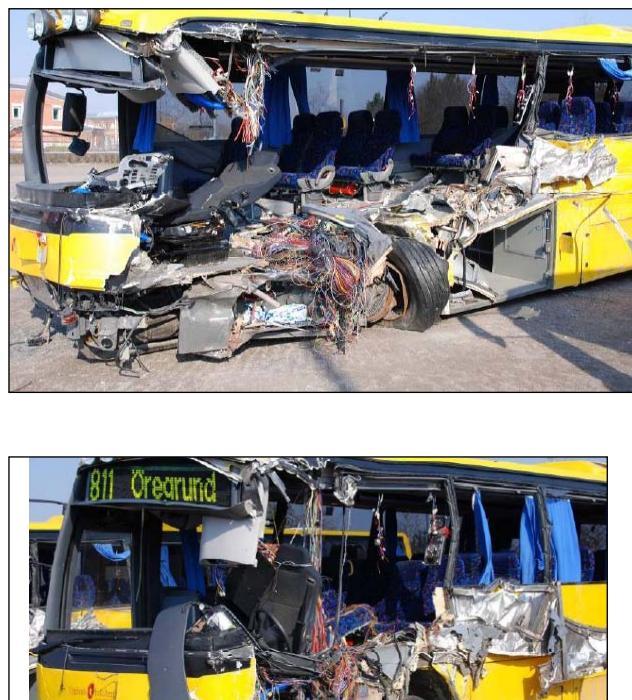
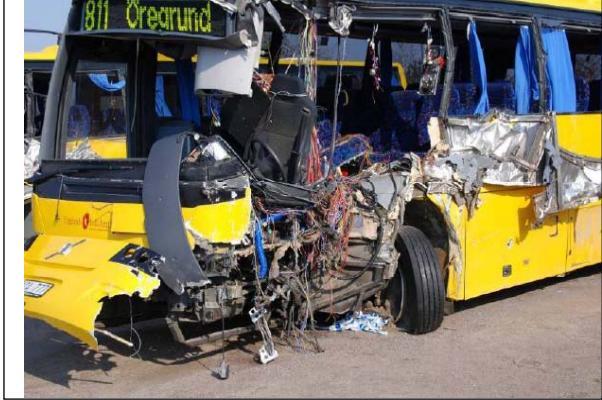
Figure 14. The two buses that collided at Rasbo/Uppsala were identical

Both buses had very similar deformations. The passengers in the deformation zone suffered very powerful direct penetrating force. In the bus shown in the top picture five people died; in the bus in the lower picture one person died. When the left front wheels met, they were twisted 90 degrees from their mountings. Source: Swedish Accident Investigation Board

The collision between two identical buses at Rasbo caused massive injuries to the passengers in the areas that were torn apart in the crash. The fatal injuries were primarily to the head and chest. Those who were sitting in the margin and were not directly impacted by the penetrating force received moderate to serious injuries. The rest of the passengers had mostly minor injuries, primarily cuts from the glass in combination with whiplash injuries. The whiplash injuries were caused by their heads hitting the seat in front of them and being bent backwards (see Figure 15). More than half of the survivors had neck injuries (whiplash-like symptoms), but none had a fracture of the cervical spine. The proportion of passengers with whiplash injuries was about the same independent of whether they were wearing a seat belt or not [15]. It is remarkable that some of the involved stated that the belt had not locked and consequently had not restrained them in the crash.

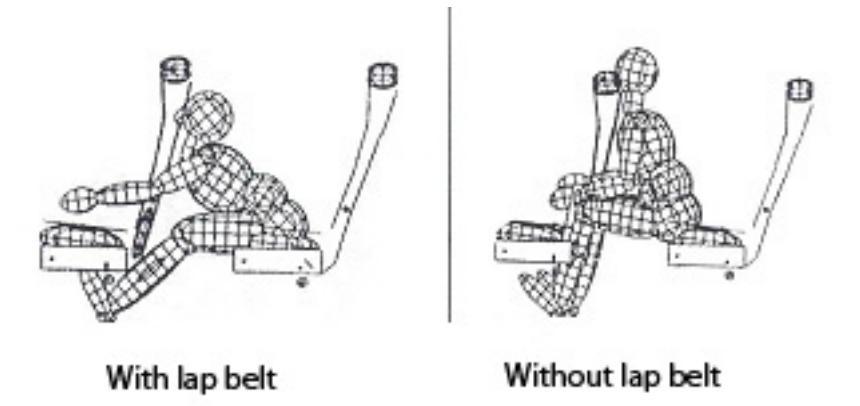
Figure 15. Passengers using a seatbelt can be subjected to a more violent backward flexing of the neck than those without a belt

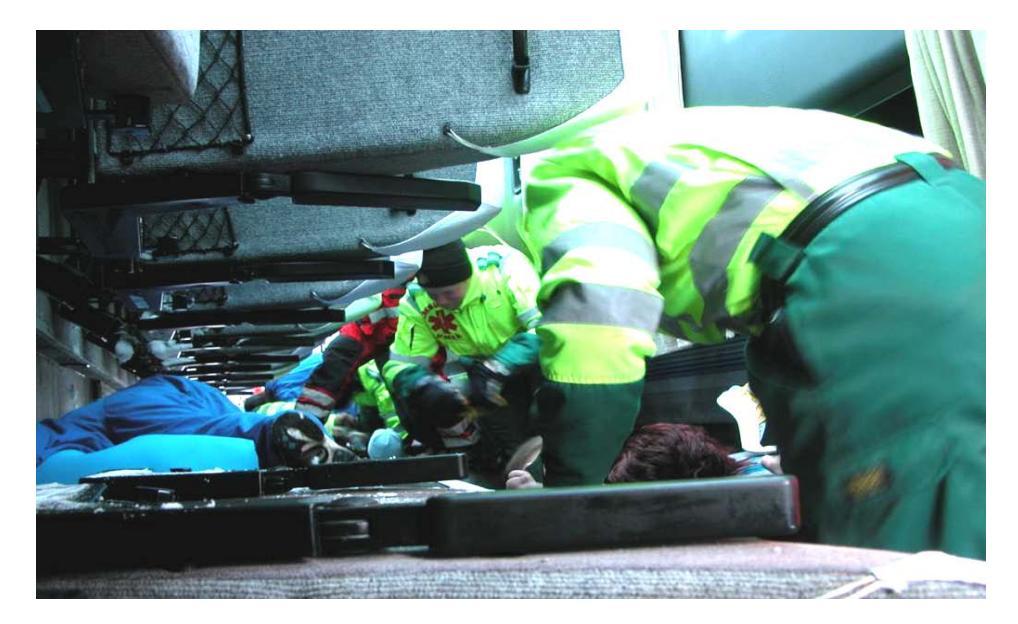
Figure 17. Photograph from an exercise illustrating the environment in a bus lying on its side. Here it is necessary to step on the windows to move around in the bus and to get access to the injured. The injured may be piled up on top of each other because they have not used the seatbelt

In the cases, where the bus rolled 90° , the ambulance and rescue personnel entered the bus via the front and rear windscreens. In the crash at river Granån, the bus had landed across the small river and the rescuers were uncertain as to whether the side windows of the bus would hold if they walked on them. The windows did, however, bear the weight, and later research has shown that the windows are usually double and relatively strong, as they are load-bearing structures in the construction of the bus. Personnel who have worked in a bus lying on its side have described it as a very unusual situation: no floor to walk on, people lying on top of each other, and so on (Figure 17).

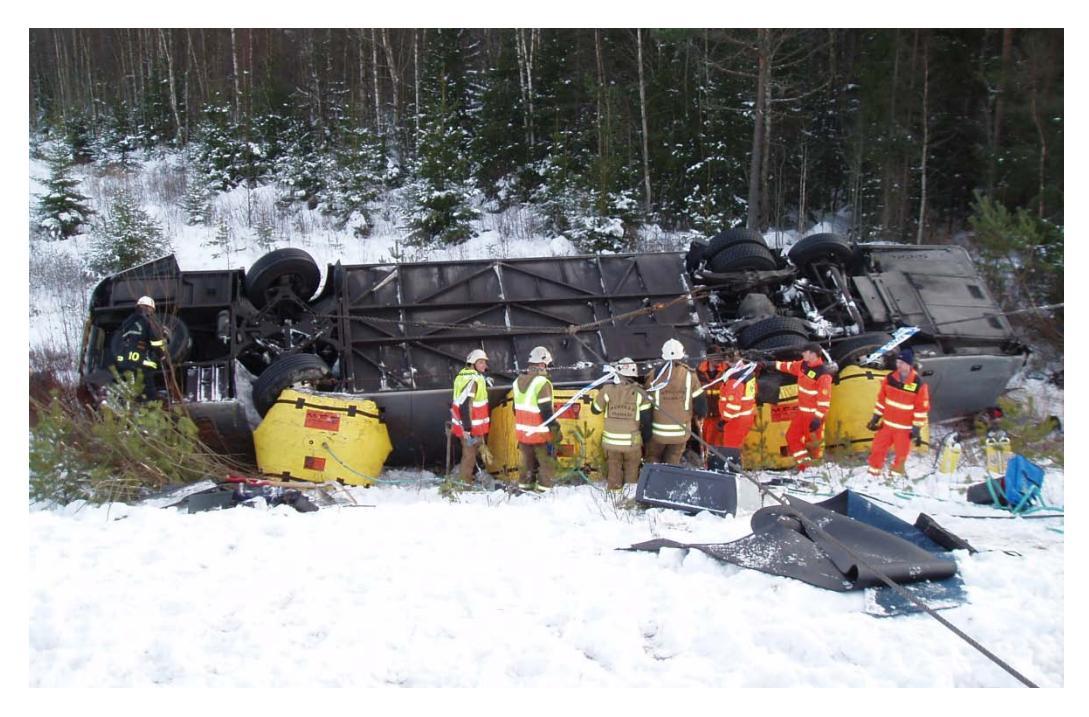
Figure 18. The photo shows how, at the Arboga crash, the rescue service tried to roll the bus up onto large airbags to ease the pressure on trapped passengers squeezed between roof and interior.

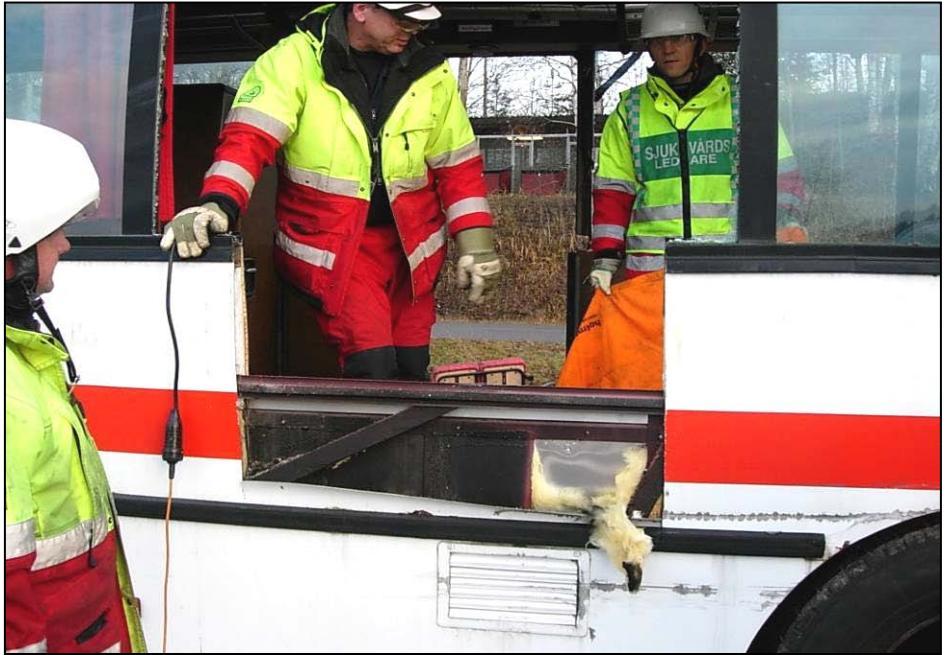
Figure 20. An opening from a window space downwards makes it easier to gain access to the bus

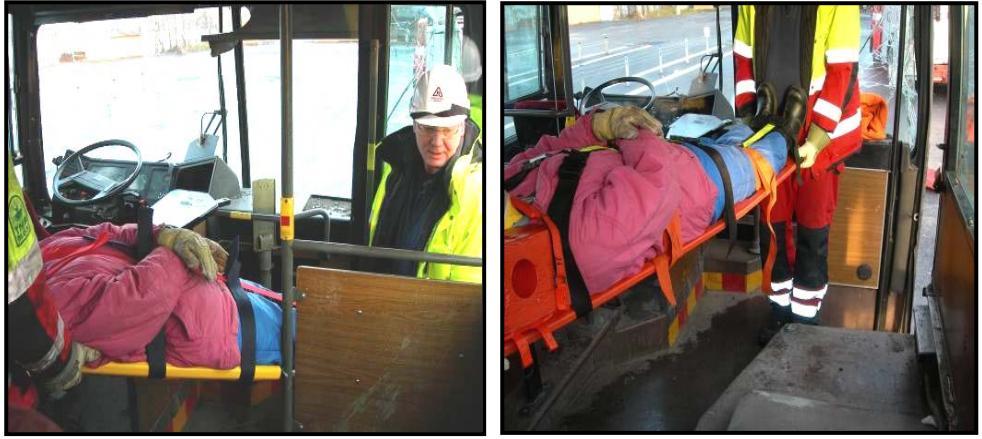
Figure 21. In order to be able to evacuate casualties from a bus standing on its wheels it may be necessary to cut away seats and partitions by the exits in order to provide more room to manoeuvre a stretcher, as in the right hand picture

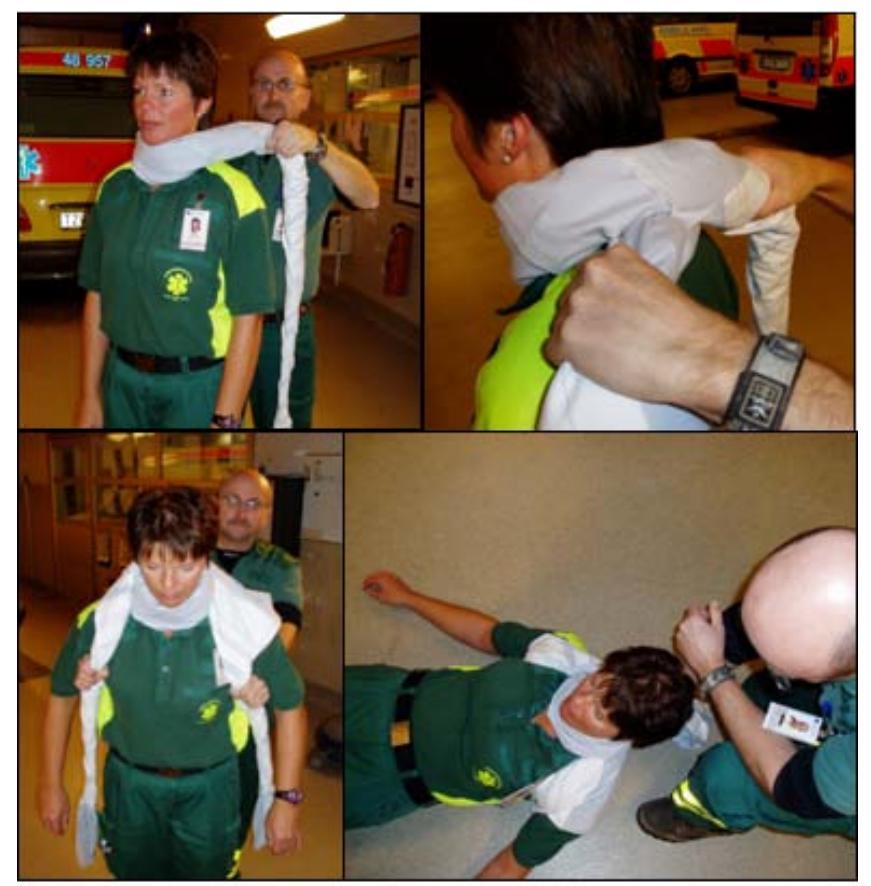
Figure 22. The picture sequence shows how a twisted sheet can form a sling which may be of great help in evacuating casualties

As the space in which to work is restricted on the bus, it may be a good idea to use a sling (see Figure 22) to pull the passengers from narrow spaces and onto for example a spine board. Sharp edges and glass need to be covered and medical equipment that is easy to manoeuvre should be used.

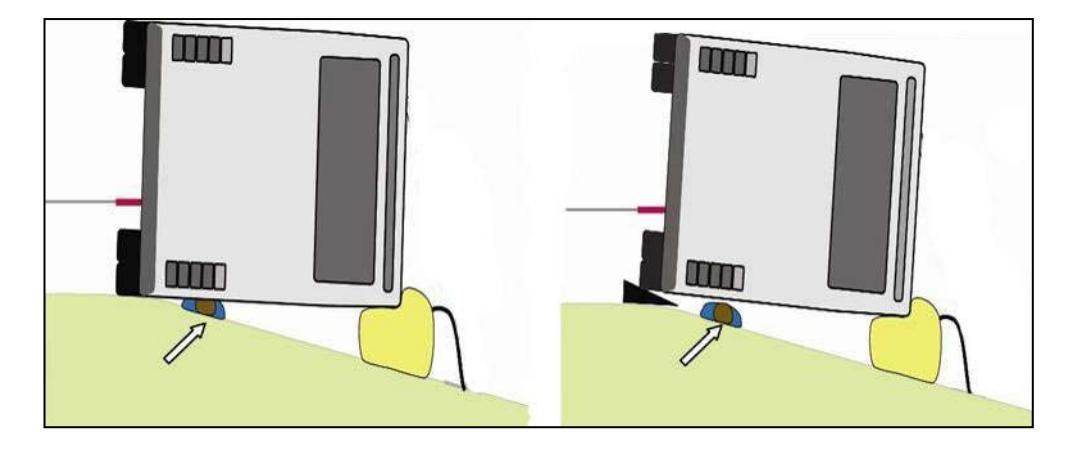
Figure 23. Schematic depiction of how the bus should be raised on wedges knocked in on the wheel side to not squeeze a victim under the bus.

The wedges are used to reduce the pressure on people who are trapped beneath the bus. The wedges have to be placed correctly around the wheels and knocked in as far as possible in order for the bus to be raised in the right way. Source: Gunno Ivansson, National Rescue Services Agency Figure 24. Two hydraulic cylinders, placed at each corner of the roof hatch, provide a rapid and stable lift of a bus with a steel chassis

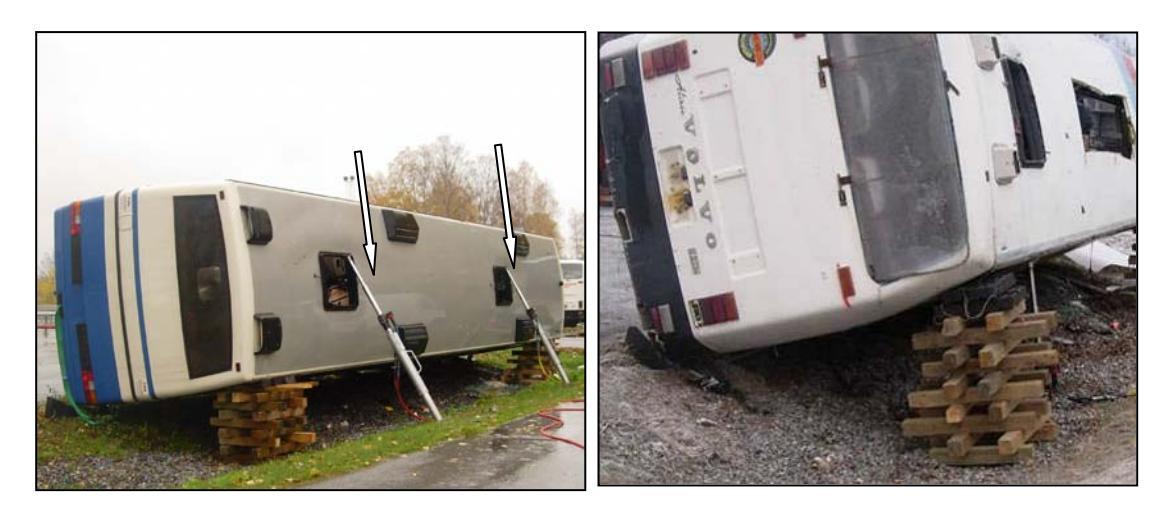
An effective safety base, in this case of wood parts, is necessary to assure against structural collapse or similar.

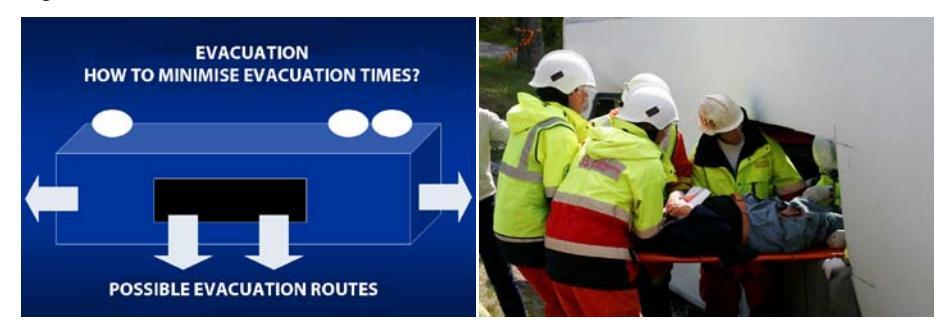
Evacuation proceeds much more rapidly with an opening hole in the roof, which takes two minutes to cut with a circular saw
